THE CURTAIN WALL OF MARLBOROUGH CASTLE

By H. C. BRETNALL, F.S.A.

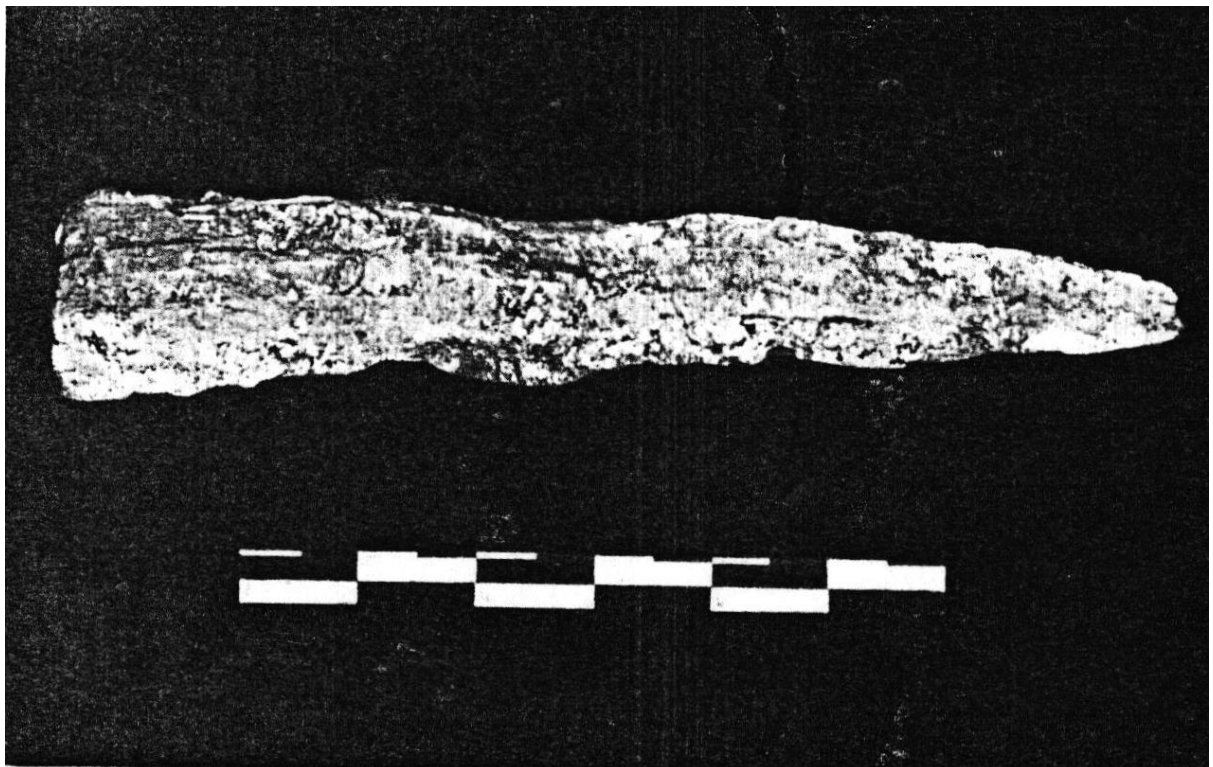
Peg apparently used by the surveyors for the original layout of the curtain wall (Scale in inches, Photographed by R. H. Lane).

Beyond the material of the foundations and a few odd blocks of freestone, which had evidently tumbled out of the Castle wall or been overlooked by its despoilers, the excavations yielded remarkably few by-products. No coins, for instance, in any way connected with the castle period were seen. The foreman, however, collected several slabs of stone roofing shingles showing the nail-holes for attachment and one object of peculiar interest. This was an oak peg 9¼ inches long, 1½ inches wide at the head and tapering to a chisel edge. It was found standing upright among the blocks of sarsen at the base of the wall. It is remarkably well preserved, probably owing to its having been buried in mortar, some of which still adheres to it. Unfortunately the exact position at which it was discovered was not noted, but it appears to have corresponded to the turn of the wall through the angle of seven degrees, which only became apparent at a later stage. If this is correct, the peg was used in laying out the

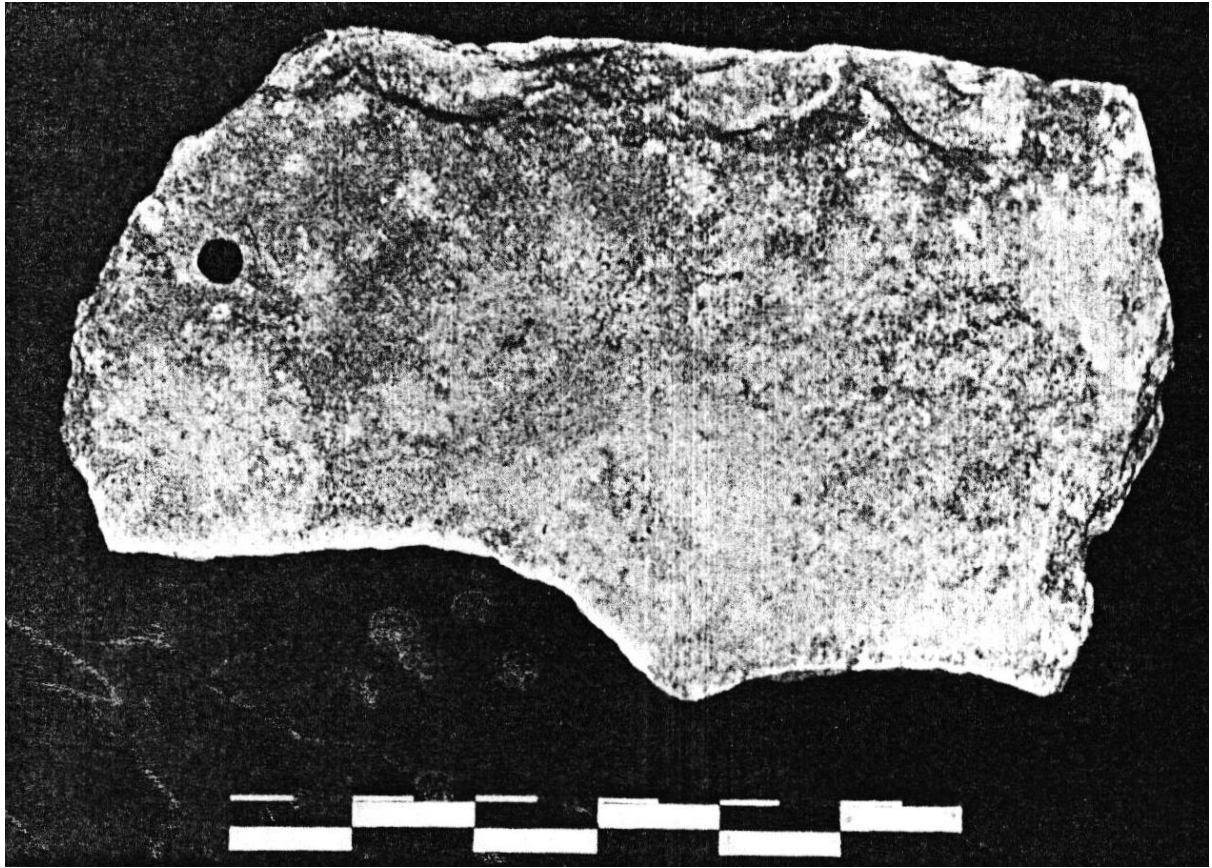
Broken roof-shingle of limestone from the excavations showing nail hole for fixing
(Scale in inches, Photographed *by* R. H. Lane).
